STRENGTHENING OF PRESTRESSED CONCRETE BOX BRIDGE AFTER FIRE EXPOSURE

Xuzheng Liu¹, Chenxi Yu¹, Wei Quan², Liang Chen³

This paper presents inspection, materials testing, field testing and parametric finite element analysis of a pre-stressed concrete box girder bridge after fire exposure. A detailed inspection of the fire-exposed bridge was performed through visual checking, photo examinations, and hammer detection. Samples of the concrete cores and reinforcing bars were tested; the residual strengths of the building materials (concrete, reinforcing bars and prestressed strands) were estimated. Furthermore, the temperatures at various depths were estimated. The data from field studies were used to validate finite element models. The structural behaviors of the original bridge prior to fire exposure were obtained via instrumentation from a reference bridge not exposed to fire. The static proof load test deflection results indicate that the stiffness decreased by approximately 23% after fire exposure and no longer satisfied the design requirement. The measured fundamental frequency of the fire-exposed span was approximately 97% of that of the original span and the theoretical fundame

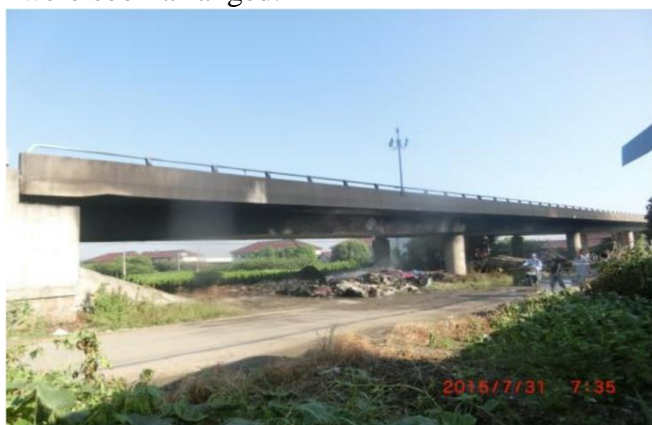
Fig. 4. Fire-damaged S12 bridge.

reported by highway patrols. The fire lasted approximately 2 h before firefighters approached and extinguished it with water at 4 a.m. According to the investigation results, the fire began in the textile wastes that were piled up below one span and propagated to nearby scrap wood below an adjacent span; however, the cause of the fire remains unclear. The vertical clearance below spans 1 and 2 is approximately 4 m. According to the extents of burning embers below the spans, the fire-affected area below each span is approximately $6 \times 15 \text{ m}^2$. The fire accident damaged the bridge elements, i.e., the

beams, columns and bearings, to various extents. The CHD Engineering Center, Inc., arrived at the fire site at 7 a.m. on the same day and performed a fire damage inspection. According to the results of the initial inspection, the S12 bridge was partially damaged by the fire, and the structural performance of the bridge was thought to have possibly decreased after the fire exposure. Therefore, the S12 bridge was immediately closed to traffic, and detour roads were soon arranged.

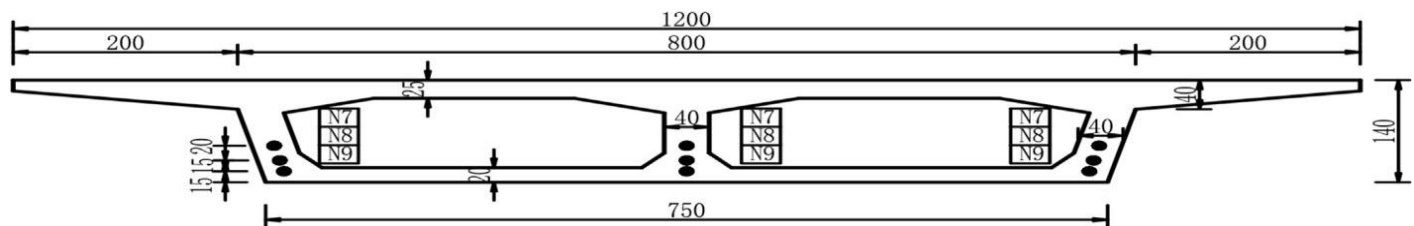
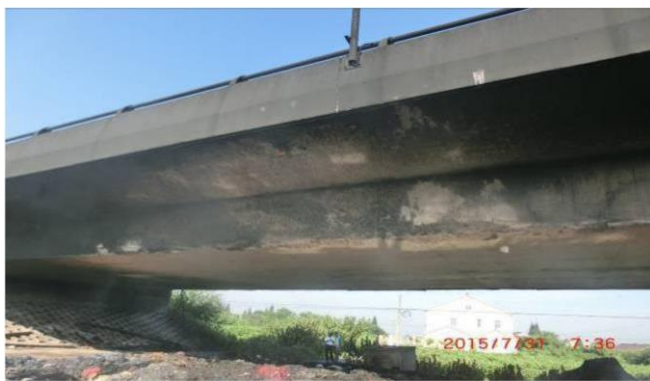
Fig. 6. Fire-damaged span 1.

The fire damage patterns indicated that the fire-damaged portions were mainly within span 1 (Fig. 6) and span 2 (Fig. 7). The typical damage on abutment 0 was soot on the front-wall surface and a light pink color and map cracking on parts of the surface concrete. No concrete spalling was observed on the abutment elements. The fire damage to the beam elements is summarized in Table 1, and a schematic of the damage to the spans is plotted in Fig. 8.

Span	Element	Damage description
span 1	right flange	Soot throughout the span, pink in the midspan ranging from 9.3 to 16.8 m, map cracking in 80% of the area with a crack width of less than 0.15 mm, cover loss in certain areas.
	right web	White-gray color ranging from midspan to pier 1, soot adjacent to abutment 0 and pink in the transition zone, rough map cracking in 40% of the area, clear concrete spalling ranging from 9.6 to 17.2 m, a maximum gap depth of 4.3 cm, and reinforcement exposed near the soffit.
	soffit	White-gray color ranging from midspan to pier 1, soot adjacent to abutment 0 and pink in the transition area, rough map cracking in 40% of the area, significant concrete spalling ranging from 3.8 to 23.8 m, a maximum gap depth of 4.3 cm, and reinforcement exposed in the area corresponding to the middle web.
	left web	Soot throughout the span, white-gray color in the midspan near the soffit, local rough map cracking, concrete spalling ranging from 5.6 to 15.6 m, a maximum gap depth of 3.5 cm, and reinforcement exposed near the soffit.

left flange	Soot throughout the span, no clear cracking, spalling or cover loss.
	others	The bottom corrugated pipe in the right web was exposed with a drill, and the pipe shape remains. The pattern on the surface was blurred and melted. Part of the corrugated pipes of the web tendon in the severely damaged area, located 15 cm from the bottom and 19.4 cm from the edge of the right web, was removed and tested in the laboratory, and the testing results are provided in subsequent sections.
span 2	right flange	Soot throughout the majority of the span, pink within 5 m located at L/4, map cracking in these areas, and a crack width of less than 0.15 mm.
	right web	Soot throughout the span, white-gray color near L/4, pink in the transition area, rough map cracking in 10% of the area, significant concrete spalling ranging from 9.6 to 15.7 m, and a maximum gap depth of 3.5 cm.
	soffit	Soot throughout the span, white-gray color near L/4, pink in the transition zone, rough map cracking in 15% of the area, local concrete spalling ranging from 9.6 to 15.7 m and 5-10.8 m on the left side and from 4 to 10.4 m in the middle area, with a maximum gap depth of 5.5 cm.

left web	Soot throughout the span, white-gray color near L/4, pink in the transition area, rough map cracking in 15% of the area, local concrete spalling ranging from 5.0 to 10.8 m, a maximum gap depth of 3.5 cm, and no reinforcement exposed.
	left flange	Soot throughout the span, no clear cracking, spalling or cover loss.
	others	In part of bar in the severely damaged area located at L/4 corresponding to the position of the middle web, the surrounding concrete was removed, and the bond with the reinforcement remained good.

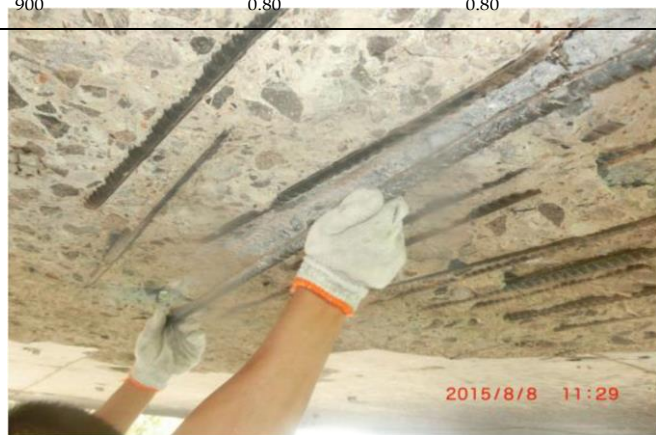
Fig. 11. Bar sample from the soffit.

reinforcing bar tensile strength under various exposed temperatures are summarized in Table 4 from CECS 252 [8]. Following the recommended assessment method, three segments of the HRB335-type reinforcing bar with a 16 mm diameter were taken from the soffit (Fig. 11) and tested via

tensile tests (Fig. 12) to ascertain the postfire bar tensile strength. According to the test results, the minimum yield strength of the postfire bar was 348.3 MPa. In addition, the initial records of the bar in the construction stage were checked, and the recorded original minimum yield strength of an HRB335 bar with a 16 mm diameter was 412.5 MPa. Hence, the calculated reduction coefficient of the bar was approximately 0.85, which corresponds to the recommended value at 700 °C. This result indicates that the temperature of the testing bar reached 700 °C during the fire exposure. Because the concrete cover spalled off during the fire, the sampled segments of the reinforcing bar were exposed. Accordingly, it is inferred that the beam surface temperature reached 700 °C during the fire.
