STRENGTHENING OF PRESTRESSED CONCRETE BOX BRIDGE AFTER FIRE EXPOSURE

Xuzheng Liu¹, Chenxi Yu¹, Wei Quan², Liang Chen³

This paper presents inspection, materials testing, field testing and parametric finite element analysis of a pre-stressed concrete box girder bridge after fire exposure. A detailed inspection of the fire-exposed bridge was performed through visual checking, photo examinations, and hammer detection. Samples of the concrete cores and reinforcing bars were tested; the residual strengths of the building materials (concrete, reinforcing bars and prestressed strands) were estimated. Furthermore, the temperatures at various depths were estimated. The data from field studies were used to validate finite element models. The structural behaviors of the original bridge prior to fire exposure were obtained via instrumentation from a reference bridge not exposed to fire. The static proof load test deflection results indicate that the stiffness decreased by approximately 23% after fire exposure and no longer satisfied the design requirement. The measured fundamental frequency of the fire-exposed span was approximately 97% of that of the original span and the theoretical fundame

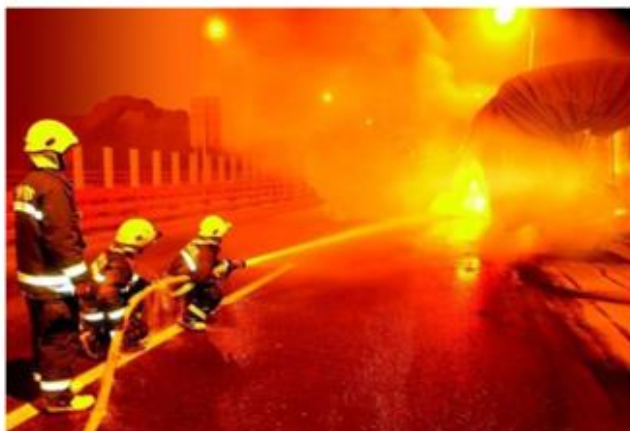
Fig. 1. Fire accident on a bridge deck.

According to a survey of the positions of previous bridge fires, there are two common fire sites: on the bridge deck and below the bridge span. When vehicles carrying hazardous materials (such as flammable or spontaneously combustible materials) travel on a bridge deck, they can be regarded as potential fire dangers. For example, Fig. 1 shows a fire caused by a coal truck on the Barlin River bridge at mile 1985 of the G60 freeway in Guizhou Province, China. Fire hazards can also occur

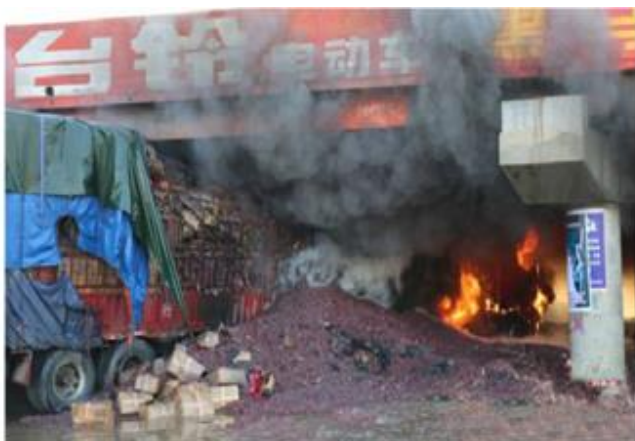
Fig. 2. Fire below the bridge span.

an accident involving a fireworks truck below an overpass span that broke out at the Daqi Road/G4 Expressway interchange near Hebi City in Henan Province, China. Additionally, some Chinese urban residents store flammable sundries, such as timber or straw, below bridge spans for use as shelters, and these materials have been one of the major causes of bridge fires. A fire can damage a bridge to different extents according to the fire's position and the properties of the fire [1–4].
